# BELZONA REPAIRS SWING SHAFT BUSHING

ID: 4886

Customer Location: *Mining Industry, USA*  
Application Date: *October 2009*

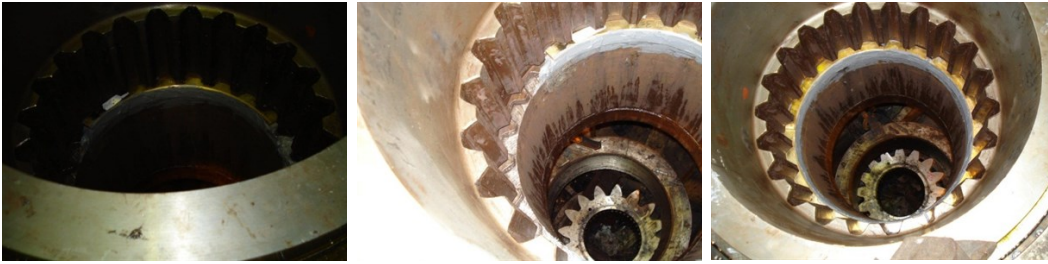
## Photograph Descriptions

*Swing shaft bushing are segmented brass and fit loosely. Belzona was used to shim the OEM bushings for a tighter fit.*

- \* Damaged bushing ,
- \* Application in progress ,
- \* Complete application ,

Damaged swing shaft bushing on a dragline

Application was carried out in accordance with Belzona Know-How System Leaflet GSS-7. Surface was cleaned and degreased from oils and prepared using hand tools.

Bushings were replaced often due to the loose fit. Belzona 1111 repair augmented the OEM fit thus improving run life.
