BELZONA SAFETY GRIP SYSTEM FOR ROOF ACCESS STAIRS

Application: FPA-Floor Problem Areas

Substrate: Terrazzo flooring

Customer Location: Markham, Ontario, Canada

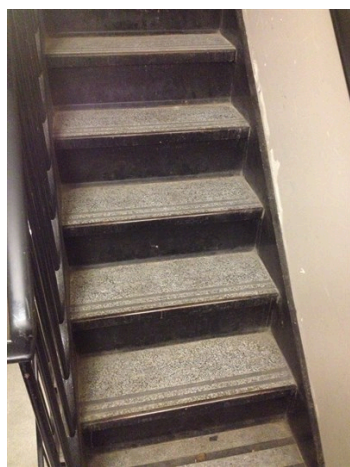
Extensive water and salt exposure had made it virtually impossible to maintain the Health and Safety requirements for any extended period of time.

- * Stairs prior to application ,
- * Preparation complete ,
- * Application in progress ,
- * Complete application ,

Application was carried out in accordance with Belzona Know-How System Leaflet FPA-8. Removed the existing adhesive tape and prepared the area ready for application. Belzona 4411 with Belzona 9211 was applied to eighteen steps and nosings.
