BELZONA SUPPORTS WINTER MAINTENANCE SYSTEM

Application: TCC-Tanks and Chemical Containment Areas

Customer Location: Kitchener, Ontario, Canada

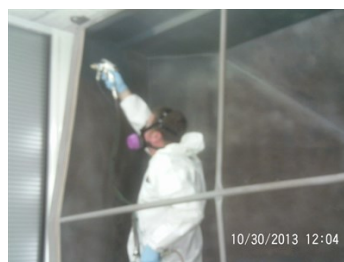
The internal walls of the salt hopper were suffering from corrosion and salt would not flow to the screw auger at the bottom.

- * External view of salt hopper ,
- * Salt hopper prior to application ,
- * Application ,
- * Completed application in service ,

The application was carried out in accordance with Belzona Know-How System Leaflet TCC-5. The surface was prepared by abrasive blasting and then two coats of Belzona 6111 were applied. Providing additional corrosion protection two coats of Belzona 5111 were applied.
