# BELZONA REPAIRS CRUSHER'S BASE

ID: 4889

**Industry:** Mining & Quarrying  
**Application:** FPA-Floor Problem Areas  
**Substrate:** Concrete and steel bar  
**Products:** \* Belzona 4111 (Magma Quartz) ,  
\* Belzona 4911 (Magma TX Conditioner) ,

**Customer Location:** Mine, BA, Brazil  
**Application Date:** January 2006

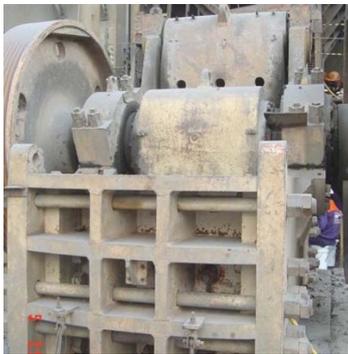
- \* General view of the crusher ,
- \* Crusher's base with exposed metal structure ,
- \* Application of Belzona 4111 ,
- \* Crusher's base repaired with Belzona technology ,

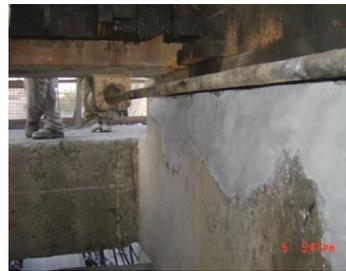
Over time, the vibration of the 100 ton machine caused the breakage of two fastening screws of the concrete base. The equipment became tilted and some parts of the concrete were already showing the metal structure, causing their oxidation. It was necessary to recover the surface with a concrete repair product with excellent mechanical resistance.
