BELZONA REPAIRS A SCREEN'S BASE

ID: 4890

Customer Location: Mine, MG, Brazil
Application Date: May, 2011

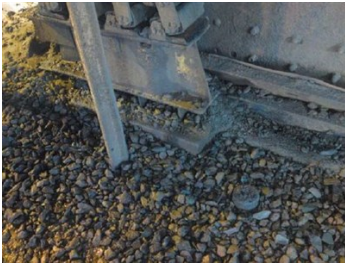
Excessive vibration generated wear and slack on the screen's concrete base, resulting in damaged anchor bolts.

- * Screen's base ,
- * Wood mold for the base ,
- * Base with Belzona 4124 ,
- * Application of Belzona 4111/4151. ,

The application was carried out based on Belzona Know-How System Leaflets TCC-9 and FPA-10. The concrete surface was prepared by mechanical scarification. Metallic surface was prepared using mechanical and manual tools according to application standards. After cleaning, the conditioner Belzona 4911 was applied on the concrete. Belzona 4124 was used to fill the base and Belzona 4111/4151 was injected to set the anchor bolts in place.
