BELZONA REPAIRS A SCREEN'S BASE

ID: 4890

Customer Location: Mine, MG, Brazil

Application: FPA-Floor Problem Areas

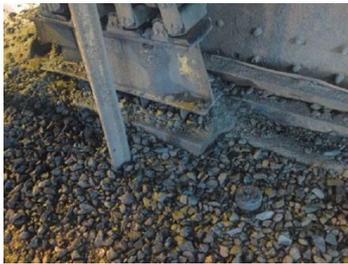
Excessive vibration generated wear and slack on the screen's concrete base, resulting in damaged anchor bolts.

- * Screen's base ,
- * Wood mold for the base ,
- * Base with Belzona 4124 ,
- * Application of Belzona 4111/4151. ,

The application was carried out based on Belzona Know-How System Leaflets TCC-9 and FPA-10. The concrete surface was prepared by mechanical scarification. Metallic surface was prepared using mechanical and manual tools according to application standards. After cleaning, the conditioner Belzona 4911 was applied on the concrete. Belzona 4124 was used to fill the base and Belzona 4111/4151 was injected to set the anchor bolts in place.
