# BELZONA APPLIES ANTI-ABRASIVE LINING ON MILL'S TRUNNION

ID: 4891

Industry: Mining & Quarrying  
Application: SHM-Solids Handling Machinery

Mill's trunnion

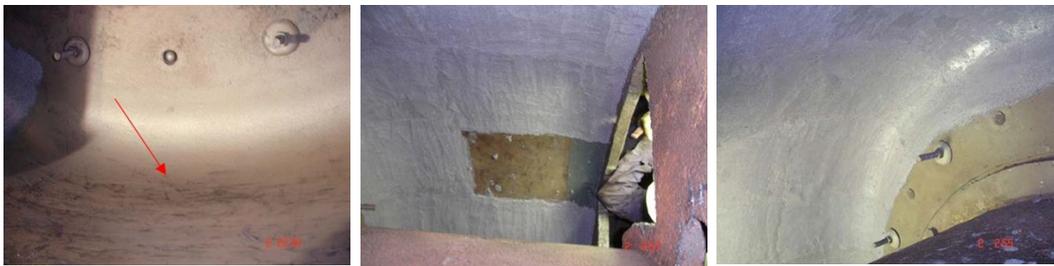
Ore, (100% solid), in contact with the trunnion, combined with humidity and room temperature, generates corrosion and abrasion. The application of a product was necessary in order to protect the worn surface against corrosion and abrasion at the operating equipment temperature of 50°C.

- \* Trunnion after blasting ,
- \* Application in progress ,
- \* Finished work. Equipment coated with Belzona 1311 and Belzona 1812 ,

This application was carried out based on Belzona Know-How System Leaflet SHM-13. Surface was prepared by grit blast (Sinter Ball) to achieve the appropriate roughness and cleanliness standards. After the surface preparation, Belzona 1311 was applied on the areas with pores in order to level the surface. After that, Belzona 1812 was applied as a final coating.
