# BELZONA SETS ANCHOR AT THE GEARBOX BASE OF ROD MILL

ID: 4893

Industry: *Mining & Quarrying*

Application: *FPA-Floor Problem Areas*

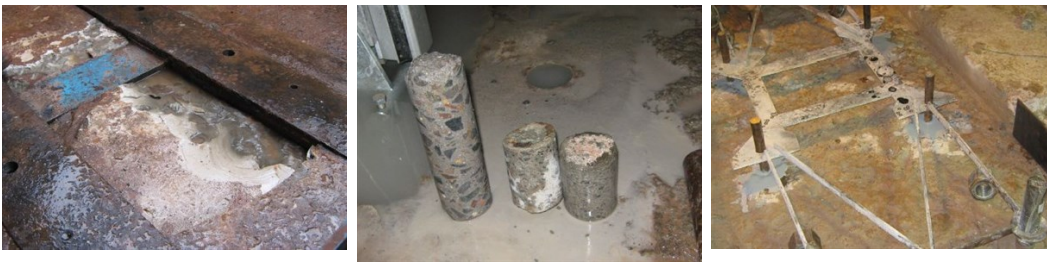
## Photograph Descriptions

*There was a need to install reinforcement at the anchoring of the concrete with base plate of the gearbox, with the addition of four extra intermediate anchors that could be set efficiently. Return to service needed to be as quick as possible as the damaged base was causing the equipment to break.*

- \* Damaged gearbox base causing excessive vibration ,
- \* Base holes to anchor's housing ,
- \* Anchors set according to template ,

There was a need to set intermediate anchors with a fast curing material with efficient anchorage on concrete base.

The application was carried out in accordance with Belzona Know-How System Leaflet FPA-10.

Belzona solution offered fast and efficient repair. Cure time was minimum, meeting client's expectations.
