BELZONA APPLIES ANTICORROSIVE COATING ON A THICKENER

ID: 4896

Customer Location: Mine, PA, Brazil
Application Date: January, 2012

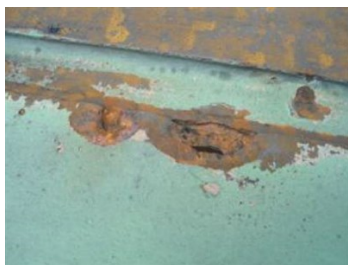
The wall area and the bottom of the thickener presented areas with localized corrosion, which needed thickness and internal lining repair. In addition protection of the steel plate against corrosion, caused by copper pulp at room temperature, was required.

- * Hole on the bottom of the thickener ,
- * Hole on the wall of the thickener ,
- * Supporting beam on the bottom of the thickener coated with Belzona 1321 ,
- * Wall coated with Belzona 5831 ,

The coating was applied on half of the internal area of the wall and on half of the support beams of the bottom of the thickener based on Belzona Know-How System Leaflets TCC-1 and TCC-5. First, the thickener was washed to remove the copper ore residues. Following the surface preparation, with dry abrasive blast to achieve near white metal finish, the holes, pits and existing welds were repaired with Belzona 1311. After that, Belzona 1321 was applied on the bottom of the thickener, and Belzona 5831 was applied on the wall.
