# BELZONA MAINTAINS CORRODED SPRINKLER TANK BY PLATE BONDING

ID: 4898

Customer Location: *Industrial Foam Manufacturer,  
Northamptonshire UK*

Application Date: *December 2013*

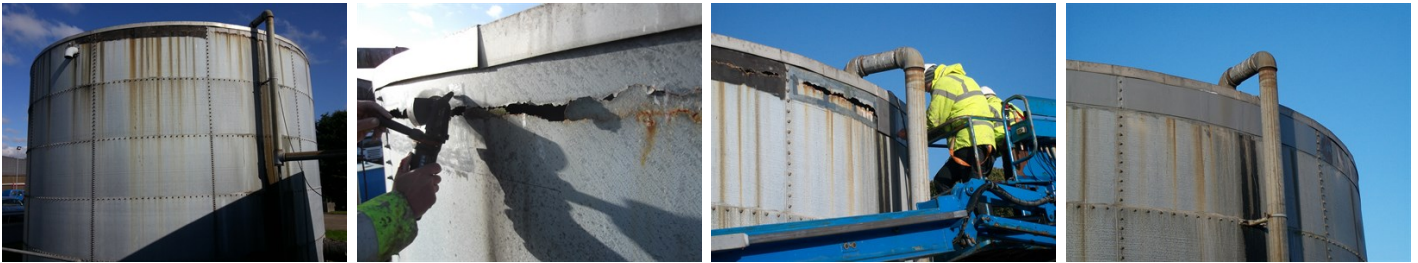
## Photograph Descriptions

*Over several years the tank had become badly corroded around approx. 50% of the circumference at the water line causing it to split open in some areas allowing water to flow out.*

\* 1. Large sprinkler tank with corrosion at water line 2. Surface being prepared with MBX Bristle Blaster 3. 400mm long x 300mm high steel plates being installed using Belzona 1161 4. Installation complete around tank circumference and coated with Belzona 5831 ,

Application was carried out in accordance with Belzona Know How System Leaflets TCC-1 and TCC-5. Doubler plates were bonded in place with Belzona 1161 before applying Belzona 5831 for overall corrosion protection.

For fire safety reasons the tank needed to be constantly on line, 24 hours a day, 7 days a week so replacing it with a new tank was not an option due to time and budget. Belzona repair completed with tank on-line.
