BELZONA SAVES CORRODED SPRINKLER TANK BY PLATE BONDING

Customer Location: *Industrial Foam Manufacturer,
Northamptonshire UK*

Application: *TCC-Tanks and Chemical Containment
Areas*

Application Date: *December 2013*

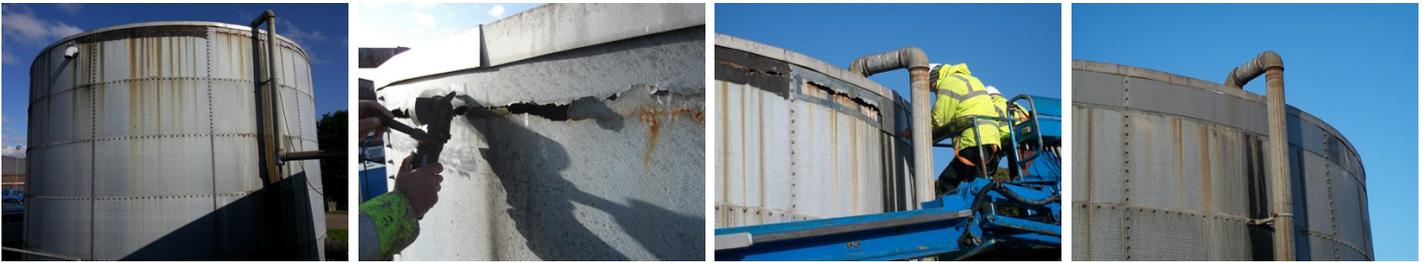
Photograph Descriptions

Over several years the tank had become badly corroded at the water line around approx. 50% of the circumference, causing it to split open in some areas with water constantly flowing out.

- * Large sprinkler tank with corrosion at water line ,
- * Surface being prepared with MBX Bristle Blaster ,
- * 36 off 400mm long x 300mm high steel plates being installed using Belzona 1161 ,
- * Installation of steel plates completed and coated with Belzona 5831 ,

Application was carried according to Belzona Know How System Leaflet TCC-1. The tank surface to be re-plated was cleaned and abraded using an MBX Bristle Blaster to create a profile. 36 off steel plates each 400mm long x 300mm high x 3mm thick were bonded in place with Belzona 1161 using 4 x countersunk screws per plate to hold them in place. The ends of the new plates were ground to create a "V" where they butted together, and filled with Belzona 1161 after installation to seal the joints and bond all the plates together. The plates were then coated with Belzona 5831.
