# BELZONA RESTORES JAPANESE ALUMINUM END COVERS

Industry: *Pulp & Paper*  
Application: *GSS-Gaskets, Seals and Shims*  
Substrate: *Aluminum*  
Products: *\* Belzona® 1121 (Super XL Metal) ,*  
*\* Belzona® 1321 (Ceramic S-Metal) ,*

Customer Location: *Paperboard Mill in Ontario, Canada*  
Application Date: *September 1999*

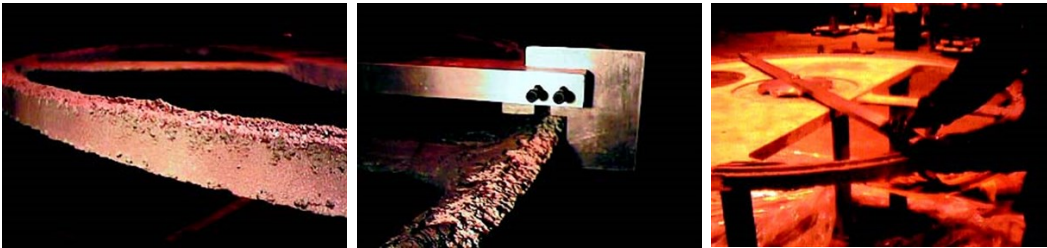
## Photograph Descriptions

*Severe erosion caused by a combination of corrosive environment and abrasion of a fanbelt.*

- \* The corroded end cover. ,
- \* Work in progress. ,
- \* The end cover repaired and ready for service. ,

Aluminum end covers from formers of Kobayashi paper machine. Six formers with two end covers per machine.

The application was carried out in accordance with a modified version of Belzona Know-How Leaflet GSS-10.
