BELZONA PROTECTS INTERNAL BASE OF SEPARATOR

ID: 490

Customer Location: Oil Refinery-Australia
Application Date: May 2004

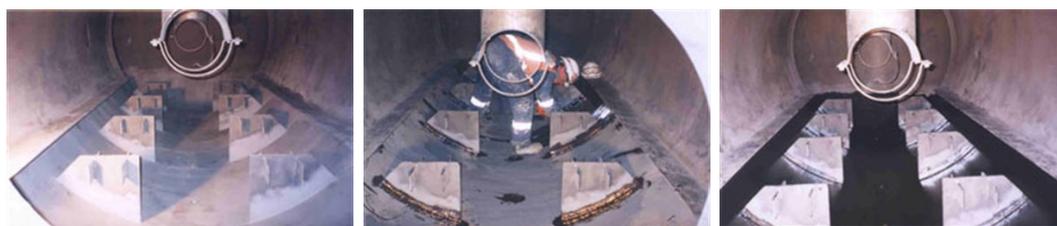
Photograph Descriptions

Internal erosion corrosion in lower section of separator.

- * Base of vessel grit blasted ,
- * Stripe coating of welds carried out ,
- * Completed application ,

Application was carried out in accordance with Belzona Know-How System Leaflet TCC-5. After thorough cleaning, the vessel was grit blasted and coated with the Belzona® 1591 taking care to initially stripe coat around the attachment bracket welds.
