# BELZONA PROTECTS INTERNAL BASE OF SEPARATOR

ID: 490

Customer Location: *Oil Refinery-Australia*  
Application Date: *May 2004*

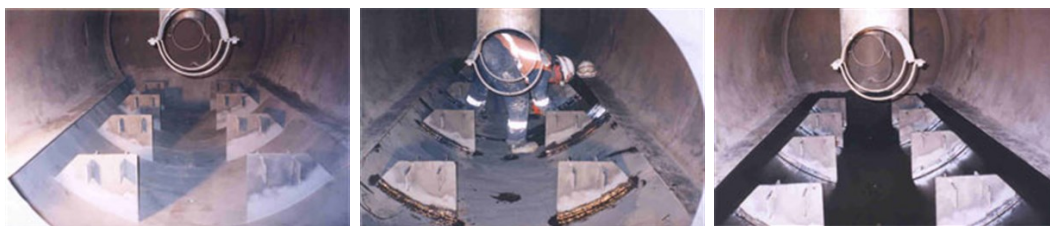
## Photograph Descriptions

*Internal erosion corrosion in lower section of separator.*

- \* Base of vessel grit blasted ,
- \* Stripe coating of welds carried out ,
- \* Completed application ,

Application was carried out in accordance with Belzona Know-How System Leaflet TCC-5. After thorough cleaning, the vessel was grit blasted and coated with the Belzona® 1591 taking care to initially stripe coat around the attachment bracket welds.
