# SHAFT REPAIR AT WASTE WATER PLANT

ID: 4904

Industry: *Water / Wastewater*  
Application: *MPT-Mechanical Power Transmission*

Customer Location: *Leamington, Ontario, Canada*  
Application Date: *April 2013*

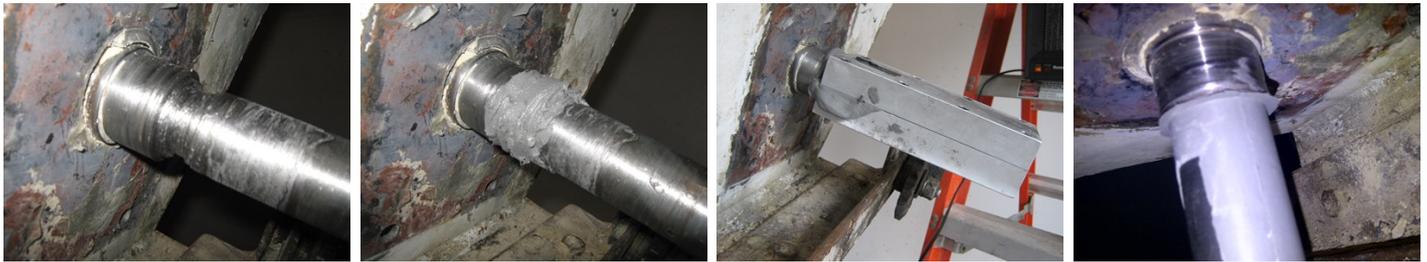
*Shaft became worn due to bearing failure*

- \* Shaft prior to the application ,
- \* Application in process ,
- \* Application with formers ,
- \* Formers removed and application completed ,

Damaged shaft at a waste water plant

Application was carried out in accordance with Belzona Know-How System Leaflet MPT-2. Damaged area was prepared with a grinder to make the surface rough and ready for the application. The surface of the formers were treated with Belzona 9411, applied in 2 coats in accordance with the Belzona Instructions For Use. Belzona 1111 was applied to the shaft and the formers. Then the formers were attach to the shaft allowing the Belzona 1111 to cure in accordance with the Belzona Instructions For Use. A suitable emery cloth/crocus paper was used to complete the application.
