# BELZONA APPLIES POSITIVE GRIP SYSTEM ON DRIVE PULLEY

ID: 4915

Drive pulley of main conveyor belt.

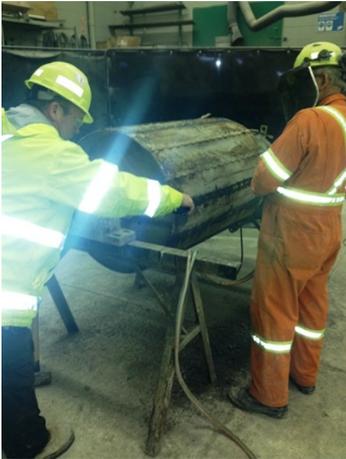
*Existing steel lagging to create traction failed. This creates exposed edges which could possibly tear the belt.*

- \* Drive pulley prior to application ,
- \* Preparation completed ,
- \* Application in progress ,
- \* Complete application ,

Application was carried out in accordance with Belzona Know-How System Leaflet SHM-12. The surface was prepared by initially grinding the steel to create a clean surface and then abraded with the MBX Bristle Blaster to create the correct surface profile. After surface preparation, duct tape was then applied to chevron pattern. Belzona 1821 was applied to the steel and Belzona 9211 was applied over the Belzona 1821 in accordance with the Belzona Instructions For Use.
