# BELZONA ADDS LIFE TO ASH LINES

Customer Location: Power station in Macedonia  
Application Date: September 2004

Pipes carrying coal ash

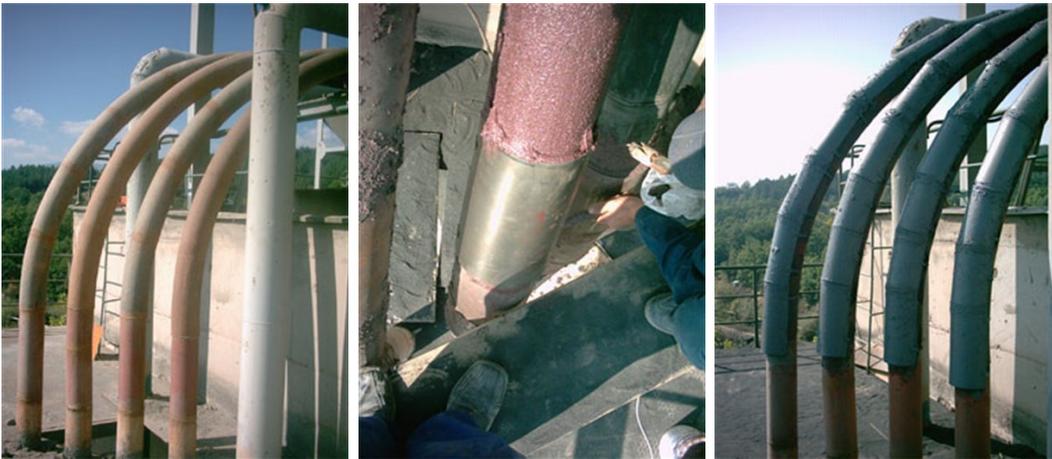
The pipes had worn thin through constant abrasion from the ash. Although not leaking, plant needed to extend life of the pipes before they failed.

- \* The pipes before preparation ,
- \* Belzona® 1811 being applied to pipe and patch ,
- \* The completed application ,

Application was carried out in accordance with Belzona Know-How System Leaflet SHM-8. Metal patches were bonded in places where pipes were known to have worn thin.

Welding had been used on small leaks but Belzona® 1811 had proven more effective both in time for application and overall abrasion resistance. Clients confidence from previous applications with Belzona® 1811 led to it being used on these pipes.
