# CORROSION PROTECTION FOR ROLLERCOASTER

ID: 4920

**Customer Location:** Vaughan, Ontario, Canada  
**Application Date:** October 2013

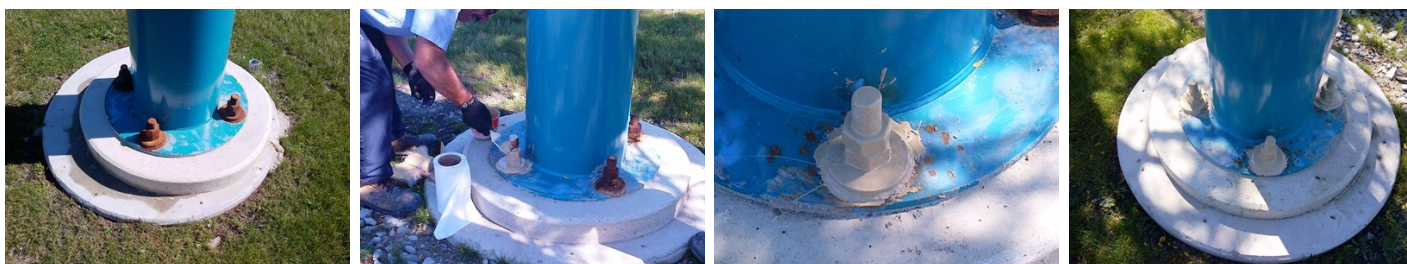
Uncoated and unprotected carbon steel structural anchor bolts exposed to outdoor elements causing Corrosion at a large theme Park attraction.

- \* Anchor bolts prior to application ,
- \* Application underway ,
- \* View of an anchor bolt finished application ,
- \* Completed application ,

The application was carried out in accordance with Belzona Know-How System Leaflet VPF-2. The surface was prepared by removing any contamination by rotary wire wheel and then cleaned with Belzona 9111. Two coats of the Belzona 5831 were applied with a brush to the anchor bolts in accordance with the Belzona Instructions For Use.
