# EFFICIENCY ENHANCEMENT KEEPS SLUDGE MOVING

ID: 4921

Industry: Water / Wastewater  
Application: CEP-Centrifugal Pumps  
Substrate: Steel  
Products: \* Belzona 1341 (Supermetalgilde) ,

Customer Location: Mississauga, Ontario, Canada  
Application Date: January 2014

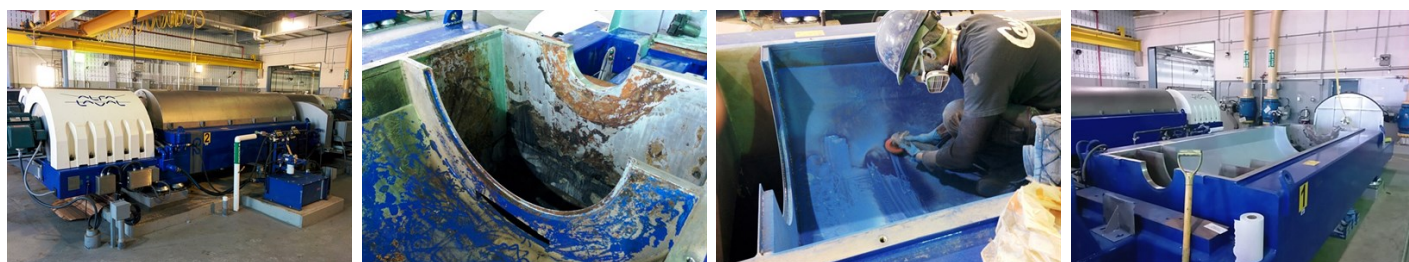
## Photograph Descriptions

The Dewatering Centrifuges were suffering from struvite and required regular cleaning and maintenance to keep them in operational condition

- \* External view of dewatering centrifuge ,
- \* Dewatering centrifuge prior to application ,
- \* Surface preparation underway ,
- \* Completed application ,

Application was carried out in accordance with a modified version of Belzona Know-How System Leaflet CEP-3. Surface preparation was done by grinding off the existing paint system and corrosion. Then carefully created a cross hatch profile to ensure a good anchor for the coating. Two coats of the Belzona 1341 were applied by brush in accordance with the Belzona Instructions For Use.
