EFFICIENCY ENHANCEMENT KEEPS SLUDGE MOVING

ID: 4921

Industry: Water / Wastewater
Application: CEP-Centrifugal Pumps
Substrate: Steel
Products: * Belzona 1341 (Supermetalglide) ,

Customer Location: Mississauga, Ontario, Canada
Application Date: January 2014

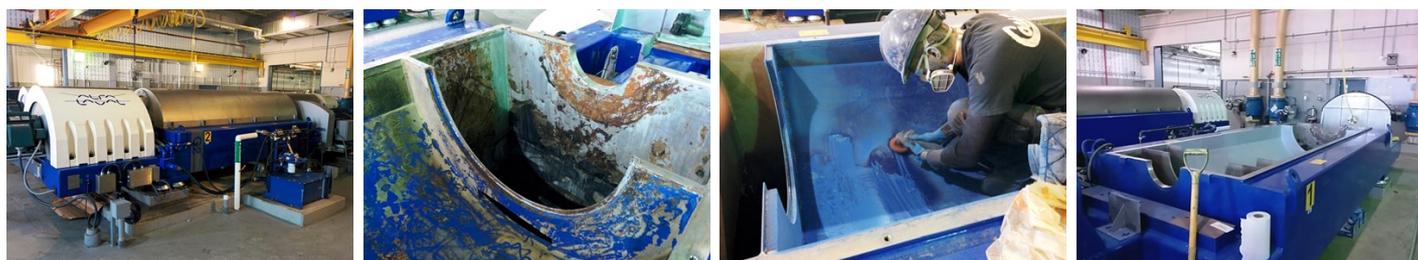
Photograph Descriptions

The Dewatering Centrifuges were suffering from struvite and required regular cleaning and maintenance to keep them in operational condition

- * External view of dewatering centrifuge ,
- * Dewatering centrifuge prior to application ,
- * Surface preparation underway ,
- * Completed application ,

Application was carried out in accordance with a modified version of Belzona Know-How System Leaflet CEP-3. Surface preparation was done by grinding off the existing paint system and corrosion. Then carefully created a cross hatch profile to ensure a good anchor for the coating. Two coats of the Belzona 1341 were applied by brush in accordance with the Belzona Instructions For Use.
