DAMAGED FLOORING IN JAIL KITCHEN

ID: 4923

Industry: Buildings & Structures
Application: FPA-Floor Problem Areas
Substrate: Ceramic tile
Products: * Belzona 4191 (Magma TX Conditioner) ,
* Belzona 4131 (Magma-Screed) ,

Customer Location: Ontario, Canada
Application Date: January 2014

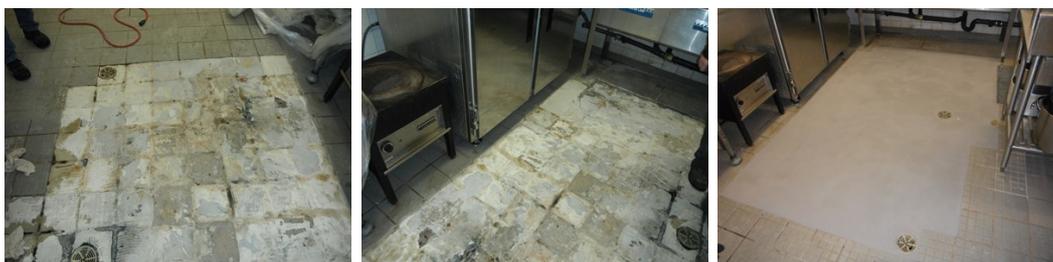
The kitchen floor tiles were undermined by water, penetrating the grout and loosening the tile adhesive causing them to lift and break. This created a Health and Safety issue.

- * Complete preparation ,
- * Kitchen floor prior to application ,
- * Complete application ,

Application was carried out in accordance with Belzona Know-How System Leaflet FPA-1. To prepare the area, the broken tiles were removed down to the concrete and cleared of any loose material or contamination and abraded to expose the aggregate. Concrete was treated with a layer of Belzona 4191 prior to the Belzona 4131 application. Belzona 4131 was applied to the area initially spreading to a general level using normal screeding technique and then smoothing off using a steel float in accordance with Belzona Instructions For Use.
