# BELZONA RESTORES ELECTROLYTE PUMP BASES & CONTAINMENT AREA

**Industry:** Mining & Quarrying  
**Application:** FPA-Floor Problem Areas  
**Substrate:** Concrete  
**Products:** \* Belzona 4131 (Magma Screed) ,  
\* Belzona 4311 (Magma CR1) ,

**Customer Location:** Copper Mine, Arizona  
**Application Date:** 2013

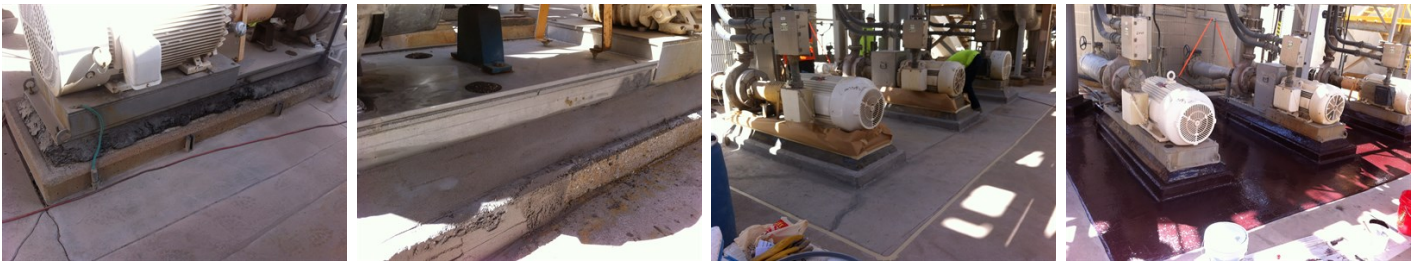
*Deterioration due to chemical attack has jeopardized production of copper. Vibration in the pumps as well as ongoing spalling and acid attack require Belzona products.*

- \* Damages to pump base caused by sulfuric acid attack ,
- \* Damages to pump base repaired with Belzona 4131 ,
- \* Completed repairs to 3 pump bases & containment area ,
- \* Final application of Belzona 4311 to prevent future chemical attack ,

Leaking copper sulfate/electrolyte with 20 % sulfuric acid, has caused damages to the pump bases and containment area.

The application was carried out in accordance with Belzona Know-How System Leaflets FPA-1 and FPA-3. Belzona 4131 was applied with a trowel. Belzona 4311 was applied utilizing a combination of paint brushes and rollers.

Belzona was installed quickly and efficiently while the pumps were fully operational. The Belzona system will prevent potential vibrations due to loss of base structural stability. This will prevent possible loss of copper production.
