BELZONA PROTECTS ELECTROLYTE RECIRCULATION TANKS

ID: 4933

Customer Location: *Copper Mine, Arizona*
Application Date: *2011 - 2012*

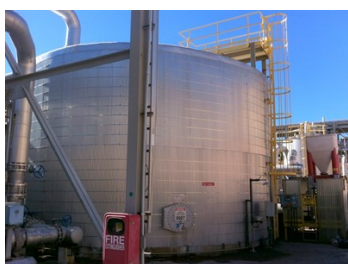
- * Overview of the electrolyte recirculation tank ,
- * Tank leaking and deteriorating the concrete containment area ,
- * Interior tank walls prior to coating ,
- * Interior tank walls following Belzona 4341 application ,
