RUBBER LINER IN SLURRY PUMP REPAIRED WITH BELZONA

ID: 4935

Industry: Mining & Quarrying
Application: SHM-Solids Handling Machinery

Customer Location: Quarry, Israel
Application Date: February 2014

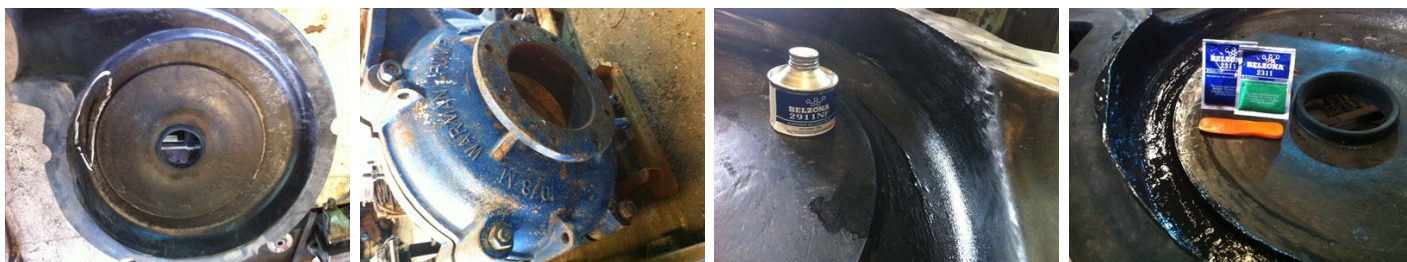
Photograph Descriptions

The rubber liner had suffered local damage resulting in an operational shutdown.

- * Damaged rubber liner ,
- * The Warman 10/8M pump ,
- * Damaged area Conditioned with Belzona 2911 (Elastomer QD Conditioner) ,
- * Rubber liner after application of Belzona 2311 ,

Rubber lined Warman 10/8M slurry pump.

Application was carried out in accordance with Belzona Know How System Leaflet SHM-9.
