# RUBBER LINER IN SLURRY PUMP REPAIRED WITH BELZONA

ID: 4935

Industry: *Mining & Quarrying*  
Application: *SHM-Solids Handling Machinery*

Customer Location: *Quarry, Israel*  
Application Date: *February 2014*

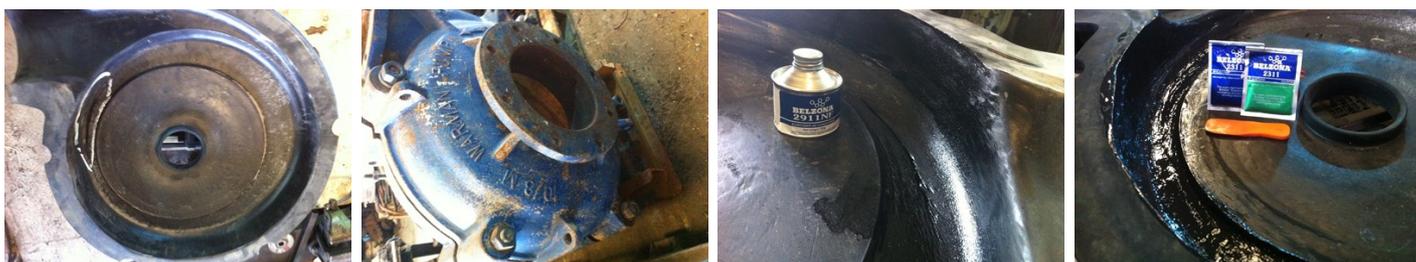
## Photograph Descriptions

*The rubber liner had suffered local damage resulting in an operational shutdown.*

- \* Damaged rubber liner ,
- \* The Warman 10/8M pump ,
- \* Damaged area Conditioned with Belzona 2911 (Elastomer QD Conditioner) ,
- \* Rubber liner after application of Belzona 2311 ,

Application was carried out in accordance with Belzona Know How System Leaflet SHM-9.

The customer was able to run the pump the same day saving shutdown costs of 7 days whilst waiting for new replacement liner.
