GARBAGE ROOM FLOOR REPAIR AND COATING AT A MALL

Application: *FPA-Floor Problem Areas*

Substrate: *Concrete*

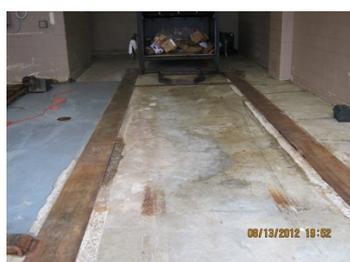
A combination of waste causing chemical attack and physical damage caused by large roll on, roll off containers.

* 1.Flooring prior to application 2.Application in progress 3.Complete application 4.Eighteen months after application ,

Application was carried out in accordance with Belzona Know-How System Leaflet FPA-1. The surface was prepared by removing any existing coating and loose material or contamination and abraded to expose the aggregate. Belzona 4131 was applied to rebuild and repair the damaged concrete. Belzona 5231 was applied to the garbage room floor with a roller in accordance with Belzona Instructions For Use.

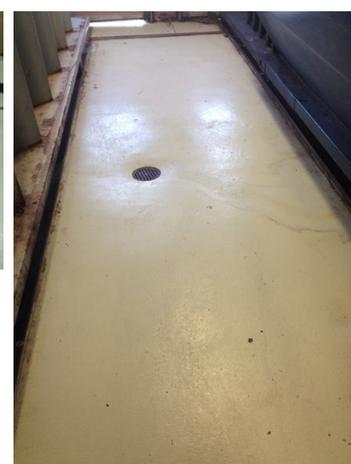
The repairs and coating provide resistance to the daily activities, wear and attack. Eighteen months after application (March 2014) the system is performing excellent.
