GARBAGE ROOM FLOOR REPAIR AND COATING AT A MALL

ID: 4936

Application: FPA-Floor Problem Areas

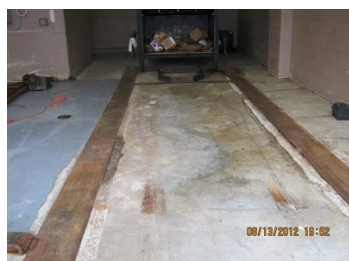
A combination of waste causing chemical attack and physical damage caused by large roll on, roll off containers.

* 1.Flooring prior to application 2.Application in progress 3.Complete application 4.Eighteen months after application ,

Application was carried out in accordance with Belzona Know-How System Leaflet FPA-1. The surface was prepared by removing any existing coating and loose material or contamination and abraded to expose the aggregate. Belzona 4131 was applied to rebuild and repair the damaged concrete. Belzona 5231 was applied to the garbage room floor with a roller in accordance with Belzona Instructions For Use.

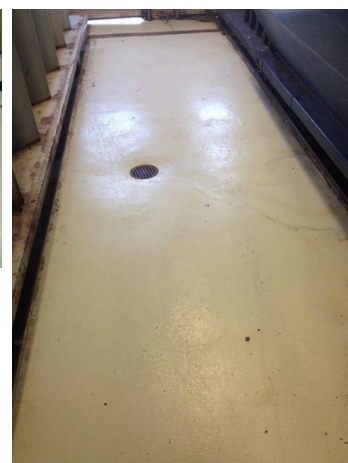
The repairs and coating provide resistance to the daily activities, wear and attack. Eighteen months after application (March 2014) the system is performing excellent.
