GARBAGE ROOM FLOOR REPAIR AND COATING AT A MALL

ID: 4936

Application: *FPA-Floor Problem Areas*

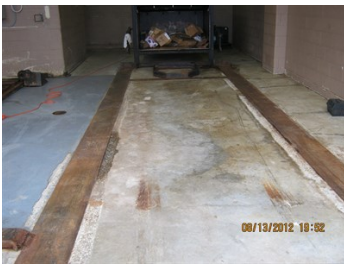
A combination of waste causing chemical attack and physical damage caused by large roll on, roll off containers.

* 1.Flooring prior to application 2.Application in progress 3.Complete application 4.Eighteen months after application ,

Application was carried out in accordance with Belzona Know-How System Leaflet FPA-1. The surface was prepared by removing any existing coating and loose material or contamination and abraded to expose the aggregate. Belzona 4131 was applied to rebuild and repair the damaged concrete. Belzona 5231 was applied to the garbage room floor with a roller in accordance with Belzona Instructions For Use.
