REPAIR AND COATING FOR A BOILER FEED PUMP

ID: 4937

Industry: Heating, Ventilation & Air Conditioning
 Application: CEP-Centrifugal Pumps
 Substrate: Steel
 Products: * Belzona 1391 (Ceramic HT) ,

Customer Location: Windsor, Ontario, Canada
 Application Date: December 2012

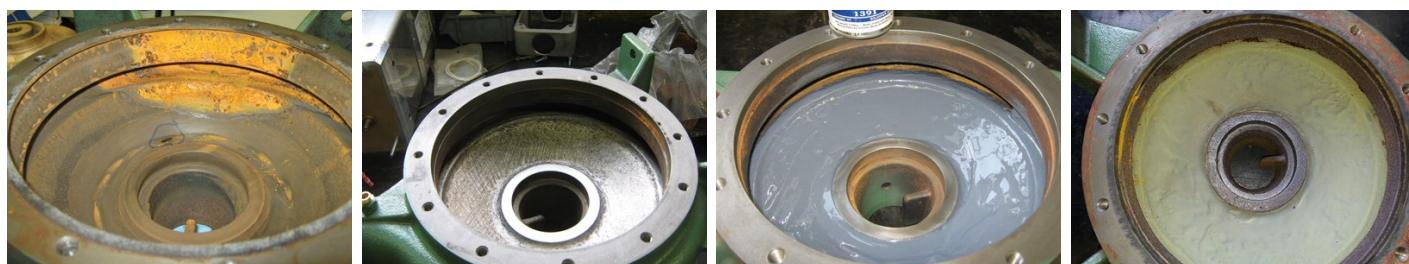
Photograph Descriptions

After 3 to 4 months in use the boiler feed pump was suffering from general corrosion/erosion and the metal shavings in the feed eventually would lead to a through hole in the casing.

- * Boiler feed pump prior to application ,
- * Preparation completed ,
- * Application completed ,
- * Fifteen months after application. ,

Application was carried out in accordance with Belzona Know-How System Leaflet CEP-5 for repair of general erosion damage. The surface was prepared by grinding the entire surface to be coated. Belzona 1391 was applied with a stiff bristle brush as a two coat system in accordance with the Belzona Instructions For Use.

Belzona 1391 has been designed to operate under continuous immersion of temperatures up to 120°C (248°F) as the boiler feed was working at a temperature of 93°C (200°F). Fifteen months (March 2014) after application the system is in great working order with no corrosion/erosion or holes.
