BELZONA PROTECTS LIKE NO OTHER

Customer Location: Chemical manufacturing company,
Florida - USA

Application: FPA-Floor Problem Areas

Protect new containment for concentrated acid storage tanks

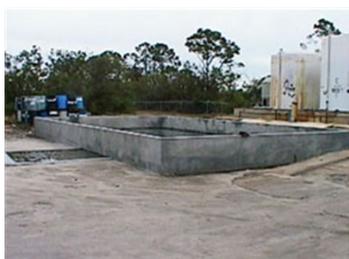
Old containment's rubber liner had failed from use and UV damage. Protection of new containment was required for continued use of acid mix down plant.

- * General view of the area ,
- * Belzona® 4911 and Belzona® 4141 applied ,
- * Belzona® 4311 coat interrupted ,
- * Belzona® 4311 applied over night, completing the application ,

Application was carried out in accordance with Belzona Know-How System Leaflets FPA-3 and TCC-15.
