BELZONA PROTECTS LIKE NO OTHER

Customer Location: Chemical manufacturing company,
Florida - USA

Application: FPA-Floor Problem Areas

Protect new containment for concentrated acid storage tanks

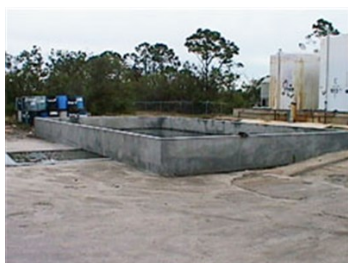
Old containment's rubber liner had failed from use and UV damage. Protection of new containment was required for continued use of acid mix down plant.

- * General view of the area ,
- * Belzona® 4911 and Belzona® 4141 applied ,
- * Belzona® 4311 coat interrupted ,
- * Belzona® 4311 applied over night, completing the application ,
