BELZONA SEALS GLAZING BARS

ID: 4972

Customer Location: *Residential building, Croatia*
Application Date: *November 2013*

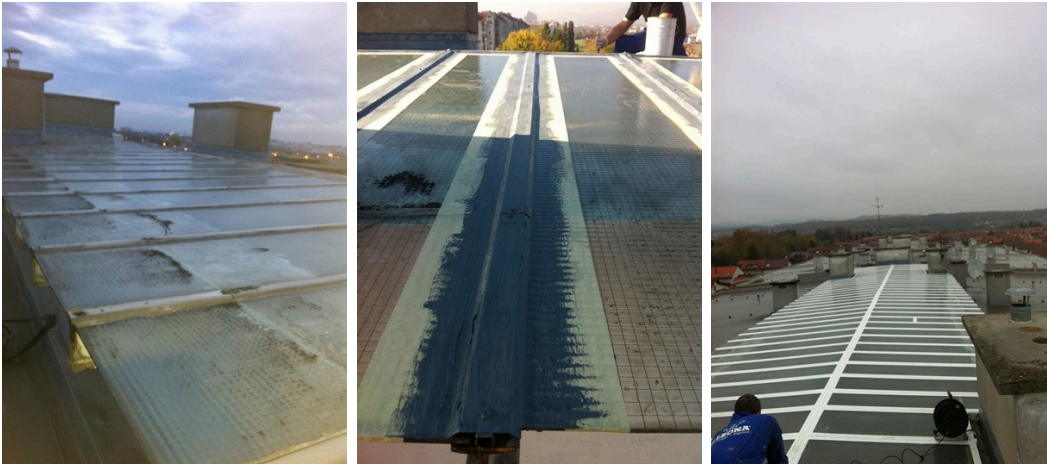
Water was penetrating the joints between aluminum frame and glass due to failure of the original sealant.

- * Damaged glazing section of the roof ,
- * Masking tape in place and Belzona 3921 conditioner applied ,
- * Application completed ,

Application was carried out in strict accordance with Belzona Know-How System Leaflet RPA-3.
