# BELZONA REBUILDS ERODED STERN TUBE SEALING FACE

Customer Location: *Maersk Lines Container Ship, Lisnave ShipYard, Setubal, Portugal*

*Galvanic corrosion damage on the boss sealing surface of stern tube system*

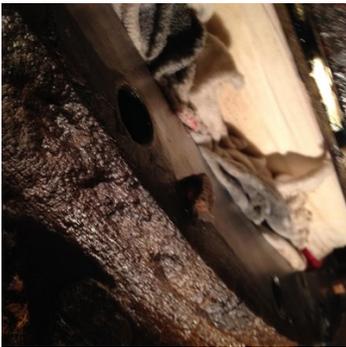
- \* Stern Tube with Galvanic Corrosion ,
- \* Stern Tube after preparation with MBX Bristle Blaster ,
- \* Stern Tube after applying Belzona 1311 ,
- \* Completed repair after polishing the Belzona 1311 ,

The traditional solution to this problem would involve precision machining of the boss surface. The initial preparation, setting up of equipment and the subsequent inspection all put together the estimated repair time for the alternative arrangement was about 8 days. The Belzona application and assembly was completed in 36 hours and inspection subsequent to the application and curing indicated a good even coat of Belzona. The system was assembled and checked for tightness satisfactorily. In normal running conditions, this repair will perform as good or better than the normal arrangement as the Belzona provides an erosion-corrosion resistant surface and being an electrical insulator will eliminate potential for galvanic corrosion in this area. The repair was completed with class ABS supervision.
