SUCCESSFUL BELZONA REFURBISHMENT OF GUTTER

ID: 4975

Industry:	Buildings & Structures	Customer Location:	Interior furnishings showroom, Northern Ireland
Application:	RPA-Roof Problem Areas	Application Date:	April 2014
Substrate:	Powder Coated Aluminium		
Products:	* Belzona 3111 (Flexible Membrane) ,

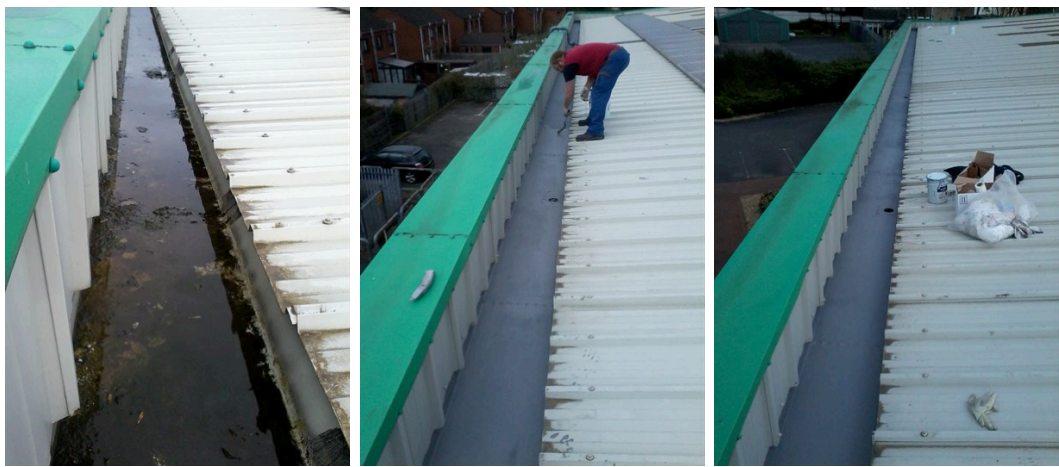
Photograph Descriptions

The client has had consistent water ingress issues from the aluminium gutters, despite repeated attempts to seal the gutter joints and seams with silicone and bitumen products. The showroom area has suffered water damage on a regular basis.

- * Gutters before application ,
- * Conditioner applied ,
- * Completed system ,

After thorough cleaning and drying of the substrate, application was carried out according with Belzona System Leaflet RPA-6. Belzona 3921 (GSC surface conditioner) was used to give optimum adhesion and a fully reinforced system incorporating Belzona 9311 (Reinforcing sheet) in the Belzona 3111 first coat was applied.
