# Belzona for Cooling Tower Basins - Even in Cold Weather

ID: 500

Application: *TCC-Tanks and Chemical Containment  
Areas*

Cooling tower basin

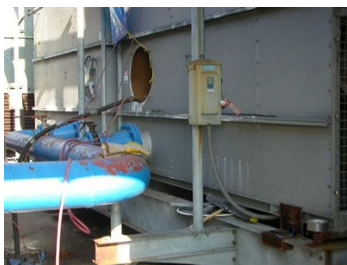
*Lack of protective coating allowed for leaks to develop.*

- \* Side of tower, showing opening ,
- \* Interior, corroded ,
- \* First coat of Belzona® 5811 ,
- \* Final coat of Belzona® 5811 - ready for service ,
