Belzona for Cooling Tower Basins - Even in Cold Weather

Application: *TCC-Tanks and Chemical Containment Areas*

Cooling tower basin

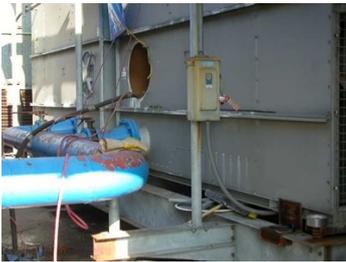
- * Side of tower, showing opening ,
- * Interior, corroded ,
- * First coat of Belzona® 5811 ,
- * Final coat of Belzona® 5811 - ready for service ,

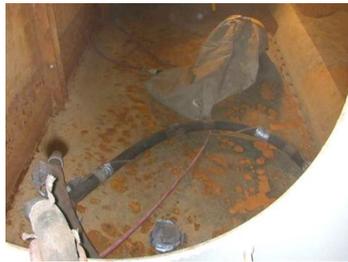
Lack of protective coating allowed for leaks to develop.

After postponing repairs for 4-5 years, the basin was leaking enough to force the issue. After surface preparation by grit blasting, there were many pin holes, but all were too small to allow the Belzona® 5811 to leak through so an impervious surface was achieved. Two cooling tower basins were protected in cold weather by placing heaters below the basin, and a tarpaulin across the top, so raising the interior temperature to 65°F (18°C).
