BELZONA 9811 EXTENDS SERVICE LIFE OF FLOP GATE AT CEMENT PLANT

ID: 5024

Application: SHM-Solids Handling Machinery

Customer Location: Bagged Concrete Plant, Virginia, USA

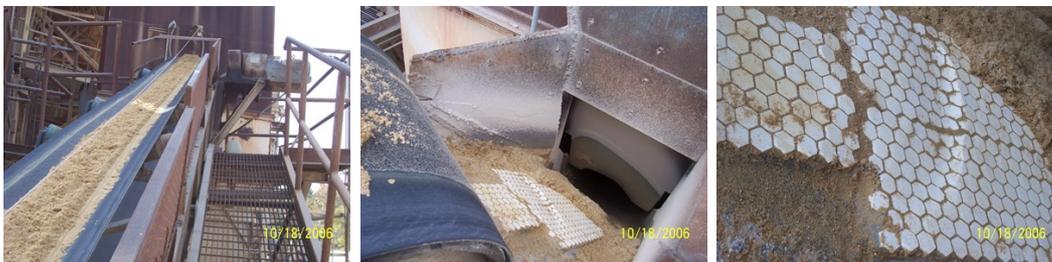
Excessive wear on the flop gate (valve) made of AR steel (AR 400). It only lasted 9 months before wearing out. Customer was looking for a longer term solution.

- * Quickcrete mixture on the conveyor belt ,
- * Flop gate repair completed ,
- * Flop gate repair close up ,

Application was carried out in accordance with Belzona System Leaflet SHM-7.

Customer was looking for an 18 month life cycle rather than the 9 months provided by AR 400. The first option, Belzona 1811 (Ceramic Carbide) lasted about 9 months, equivalent to the AR 400 steel. Belzona 9811 tiles solution has been in place since the fall of 2006.
