Belzona Protects Stadium

Customer Location: *St. Louis University, St. Louis, Missouri
USA*

Application: *RPA-Roof Problem Areas*

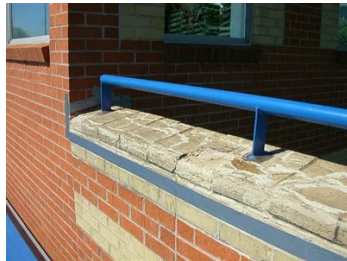
Wall caps had deteriorated to the point of either needing repairing or replacing.

- * Overall view of stands ,
- * Close up of typical damaged block ,
- * Completed south wall area ,
- * Completed north wall area ,

The application was carried out in accordance with a modified version of Belzona Know-How System Leaflet RPA-11.

Replacement cost in this situation was astronomical; the Belzona solution offered a cost effective alternative. The Belzona® 3111 was tinted to match the color of the original stone.
