# Belzona Protects Stadium

Customer Location: *St. Louis University, St. Louis, Missouri  
USA*

Application: *RPA-Roof Problem Areas*

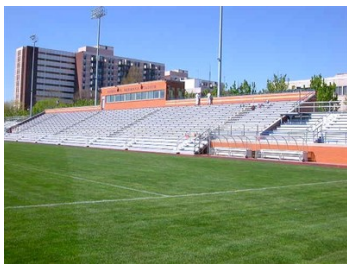
*Wall caps had deteriorated to the point of either needing repairing or replacing.*

- \* Overall view of stands ,
- \* Close up of typical damaged block ,
- \* Completed south wall area ,
- \* Completed north wall area ,
