# BELZONA SEALS LEAKS IN GLASS BLOCK WALL

Customer Location: *St. Louis University - St. Louis, Missouri  
USA*

Application: *WPA-Wall Problem Areas*

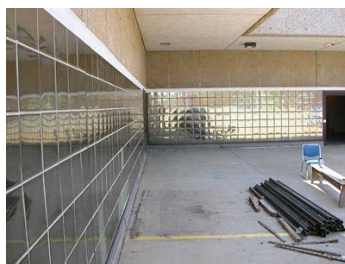
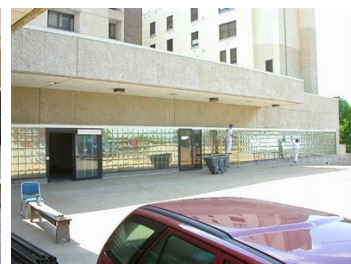
*Severe leaks causing interior damage to the ceiling and walls.*

- \* Close up of deteriorated calking ,
- \* Overall view on east wall ,
- \* Completed east wall ,
- \* Completed south wall ,

Belzona® 3111 was applied from the top of the glass over deteriorated and leaking calking and attached to the concrete wall at the top. Over the last few years, several contractors had worked on the wall at great expense without solving the problem.
