BELZONA SEALS LEAKS IN GLASS BLOCK WALL

Customer Location: St. Louis University - St. Louis, Missouri
USA

Application: WPA-Wall Problem Areas

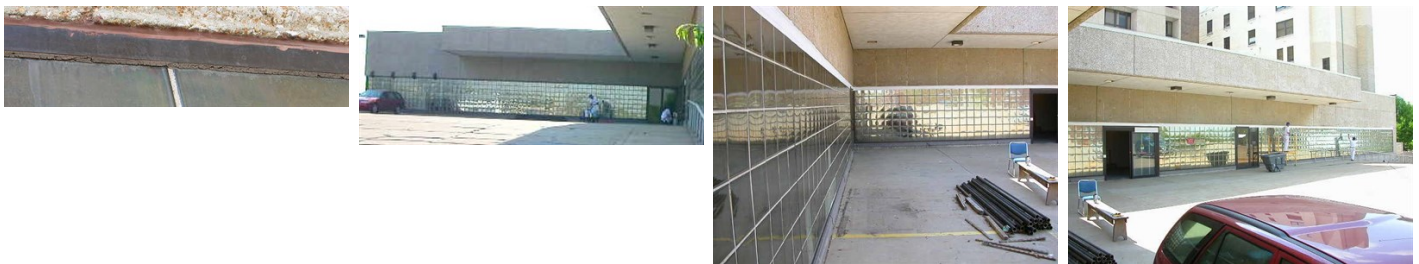
Photograph Descriptions

Severe leaks causing interior damage to the ceiling and walls.

- * Close up of deteriorated calking ,
- * Overall view on east wall ,
- * Completed east wall ,
- * Completed south wall ,

Belzona® 3111 was applied from the top of the glass over deteriorated and leaking calking and attached to the concrete wall at the top. Over the last few years, several contractors had worked on the wall at great expense without solving the problem.
