BELZONA REBUILDS DAMAGED STONework

Application: WPA-Wall Problem Areas

Customer Location: School, West Yorkshire, UK

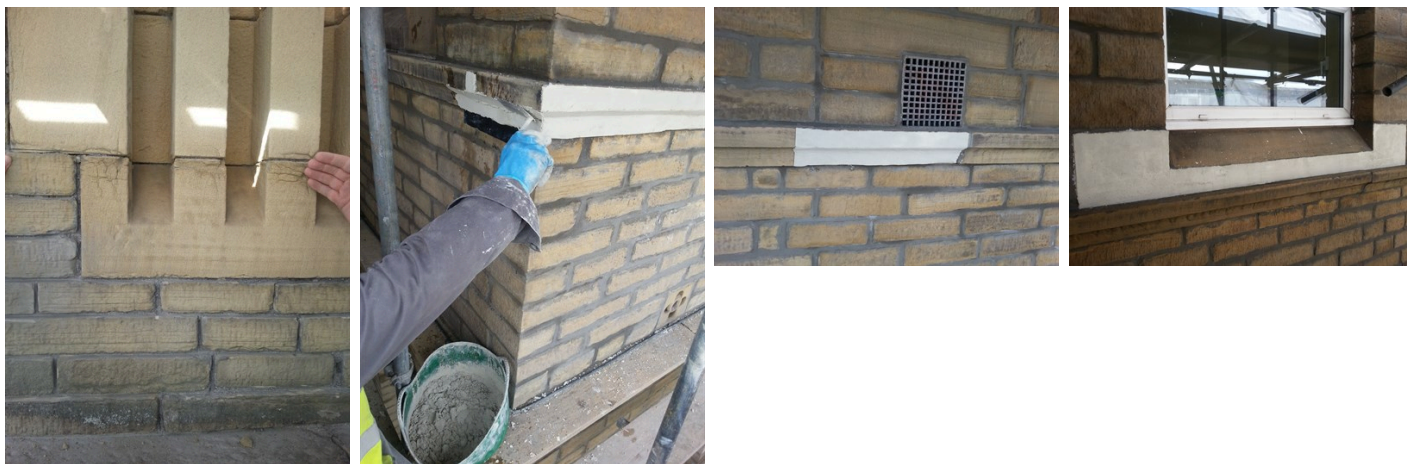
Weathered stonework needed rebuilding to improve appearance and remove risk of falling debris.

- * Before application ,
- * Local repair to corbel with shape detail ,
- * Completed application to corbel ,
- * Completed application to window sill. ,

Weathered stonework on school building.

The application was carried out in accordance with Belzona System Leaflet WPA-4. The substrate was hand prepared to remove any loose material. This was followed by application of Belzona 4911 (TX Conditioner) before Belzona 4141 was applied. This material was shaped by hand to match in with the existing stonework.
