BELZONA® Macht poröses Mauerwerk wetterfest

ID: 5084

Industrie: Gebäude & Strukturen
Anwendung: Wandproblembereiche
Substrat: Sandstein
Produkte: * Belzona® 5122 (Clear Cladding Concentrate),

Standort des Kunden: Privathaus, Manchester, England
Antragsdatum: August 2007

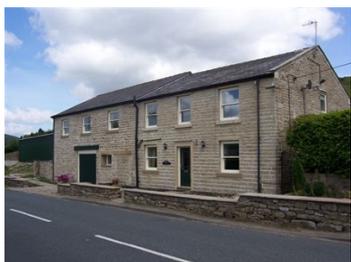
- * Ansicht der Immobilie ,
- * Abgeklebte Fenster und fertig zum Beschichten ,
- * Belzona® 5122 mit Spritzeinheit ,
- * Während der Anwendung ,
