BELZONA RUBBER LINED VALVE REPAIR

Customer Location: Regional Energy Company, Pancevo, Serbia

Application: VPF-Valves, Pipes and Fittings

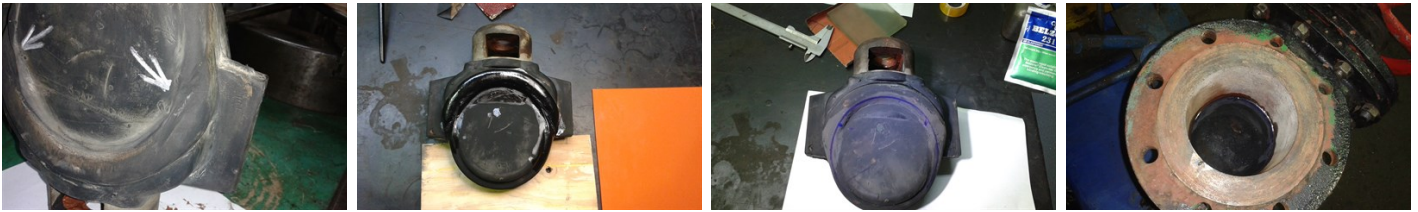
Photograph Descriptions

Valve sealing surface had deteriorated over the years causing inefficiency in stopping flow of water

- * Valve damage marked up ,
- * Prepared surface ,
- * Belzona 2311 application completed ,
- * Assembled valve to undergo pressure test ,

Application was carried out in accordance with Belzona Know-How System Leaflet VPF-5

Belzona repair was cost effective and allowed valve to be quickly returned to service. Fast curing Belzona 2311 was only solution available to the customer in the downtime available.
