# BELZONA RUBBER LINED VALVE REPAIR

ID: 5086

Industry: Power

Customer Location: Regional Energy Company, Pancevo,  
Serbia

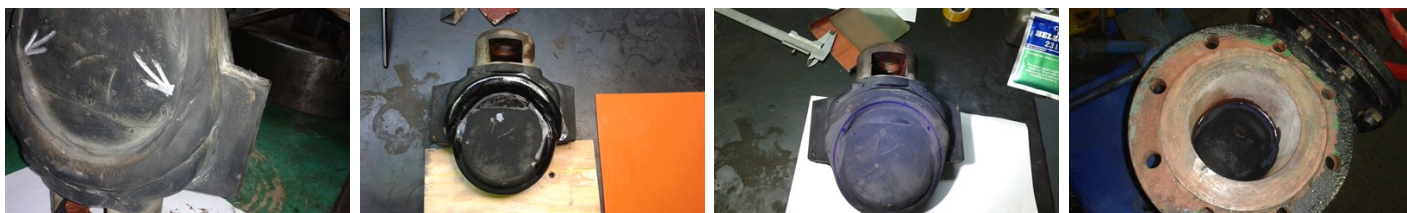
Valve sealing surface had deteriorated over the years causing inefficiency in stopping flow of water

- \* Valve damage marked up ,
- \* Prepared surface ,
- \* Belzona 2311 application completed ,
- \* Assembled valve to undergo pressure test ,

Application was carried out in accordance with Belzona Know-How System Leaflet VPF-5

Belzona repair was cost effective and allowed valve to be quickly returned to service. Fast curing Belzona 2311 was only solution available to the customer in the downtime available.
