BELZONA REPAIRS AND PROTECTS CENTRIFUGAL PUMP HOUSING IN AN INDUSTRIAL MINE

ID: 5088

Customer Location: Gold Extraction Mine, Guatemala
Application Date: December 2006

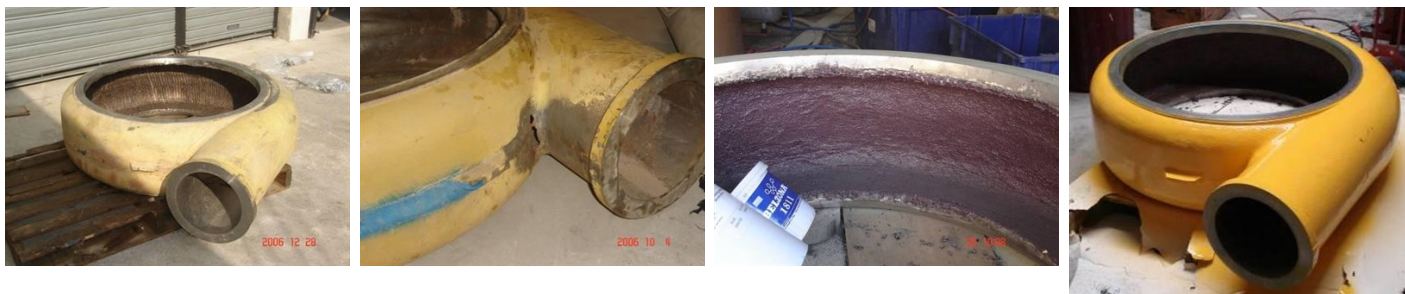
Photograph Descriptions

Due to the severe abrasive conditions caused by the suspended solids, the pump casing was severely stripped and holes appeared in the housing.

- * Centrifugal pump housing ,
- * Holes due to severe abrasion ,
- * Application of the lining ,
- * Application completed ,

Reconstruction and abrasion-resistant lining of the pump housing of the mud conveyor.

The preparation of the surface was done using a sand blasting method. The application was carried out in accordance with SSPC-SP 10 and Belzona System Leaflet SHM-11.
