BELZONA RESTORES VACUUM PUMP AFFECTED BY DEEP EROSION

ID: 5089

Interior of the central casing of a large liquid ring vacuum pump

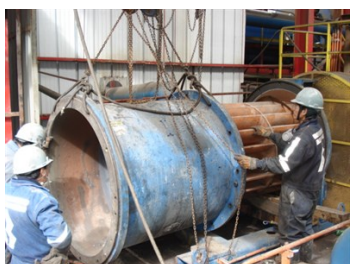
- * Disassembly of components ,
- * Grooves caused by erosion all around on both sides ,
- * Refilled with Belzona 1311 ,
- * Reconstructed area was later covered with Belzona 1341. ,

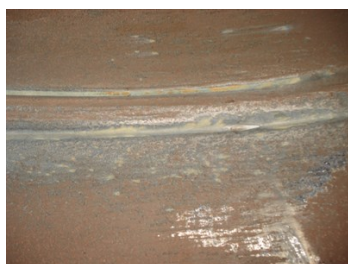
Seal water drags solids deeply eroding the central body all around, on both sides of the central ribbing weakening the casing and even making a hole at one point.
