BELZONA RESTORES VACUUM PUMP AFFECTED BY DEEP EROSION

ID: 5089

Customer Location: Mine, Peru
Application Date: April 2008

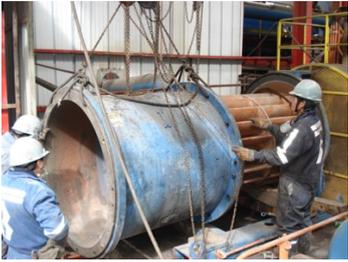
- * Disassembly of components ,
- * Grooves caused by erosion all around on both sides ,
- * Refilled with Belzona 1311 ,
- * Reconstructed area was later covered with Belzona 1341. ,

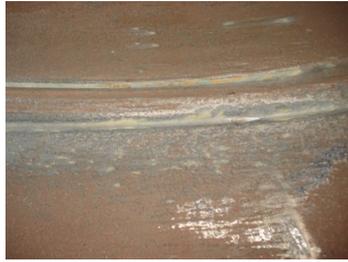
Seal water drags solids deeply eroding the central body all around, on both sides of the central ribbing weakening the casing and even making a hole at one point.
