# BELZONA COATS THE EXTERIOR OF AN ACID PUMP

**Industry:** Mining & Quarrying  
**Application:** CEP-Centrifugal Pumps  
**Substrate:** Stainless steel  
**Products:** \* Belzona 4311 (Magma CR-1) ,

**Customer Location:** Mine, Chile  
**Application Date:** October 2006

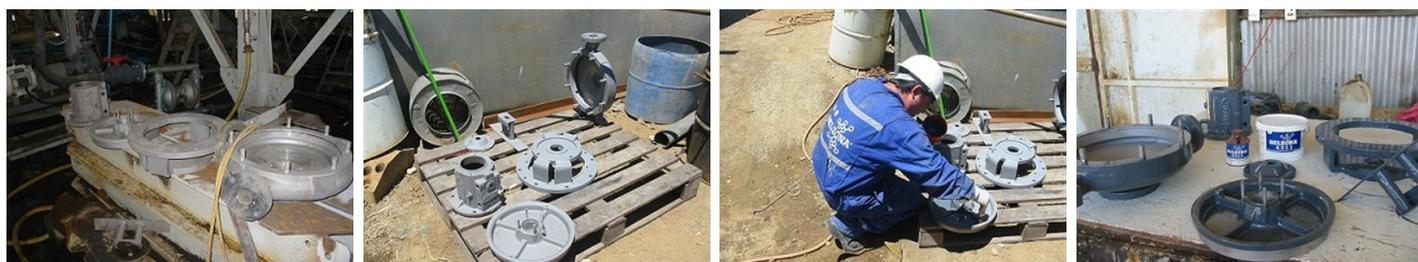
The acid spilt onto the pump, which caused the equipment to be removed from service and the pump did not last as long as the mine wanted to.

- \* First blasting of the pump ,
- \* Second blasting, ready to apply the coating ,
- \* Application of Belzona 4311 ,
- \* Pump coated with Belzona 4311 ,

The pump was blasted to white metal to eliminate the acid contained in the substrate. Then, two coats of Belzona 4311 were applied to the external part of the pump.
