BELZONA PROVIDES FAST INTERIOR PROTECTION OF TWO CYANIDE DESTRUCTION TANKS

ID: 5092

Industry: *Mining & Quarrying*
Application: *TCC-Tanks and Chemical Containment Areas*
Substrate: *Steel ASTM A36*
Products: ** Belzona 4151 (Magma-Quartz Resins) ,*

Customer Location: *Gold mine*
Application Date: *September 2009*

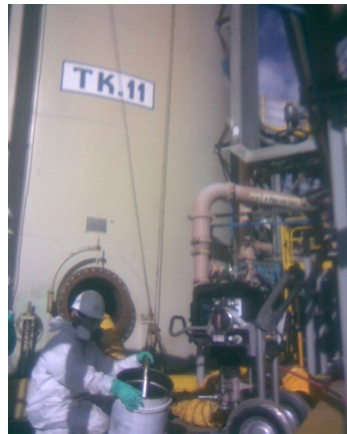
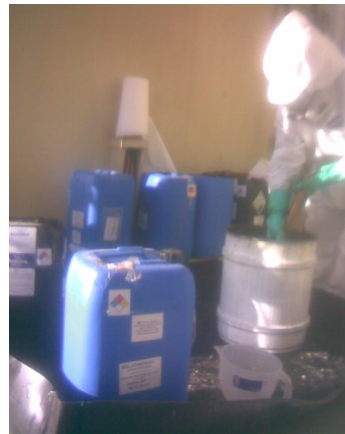
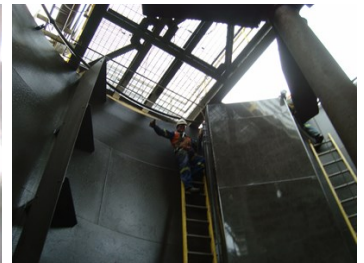
Photograph Descriptions

Aggressive chemical attack, cavitation and erosion of suspended solids in processing tanks that operate with permanent entry and exit of fluids and mixing blades.

- * Original conditions in the interior of the tank ,
- * Image of the tank and airless spray equipment ,
- * Mixing Belzona 4151 ,
- * Application completed ,

After blasting, Belzona 4151 was applied with airless spray equipment in accordance with Belzona Know-How System Leaflet TCC-5.

It is common to use paints to protect tanks, but these paints are not designed for the working conditions they are subjected to. As a result they deteriorate rapidly, which leaves the metallic parts exposed. After a technical evaluation, it was decided to apply a coating of Belzona 4151 due to its superior resistance to chemical attack, erosion and cavitation. The product was applied with Airless Graco Xtreme X70 equipment, which is able to cover large areas in a short amount of time in order to reduce downtime.
